SERVICE BULLETIN

REPLACEMENT OF WASHER PART NO. 944072 (FLY WHEEL HUB) FOR ROTAX® ENGINE TYPE 912 AND 914 (SERIES)

SB-912-058

SB-914-041

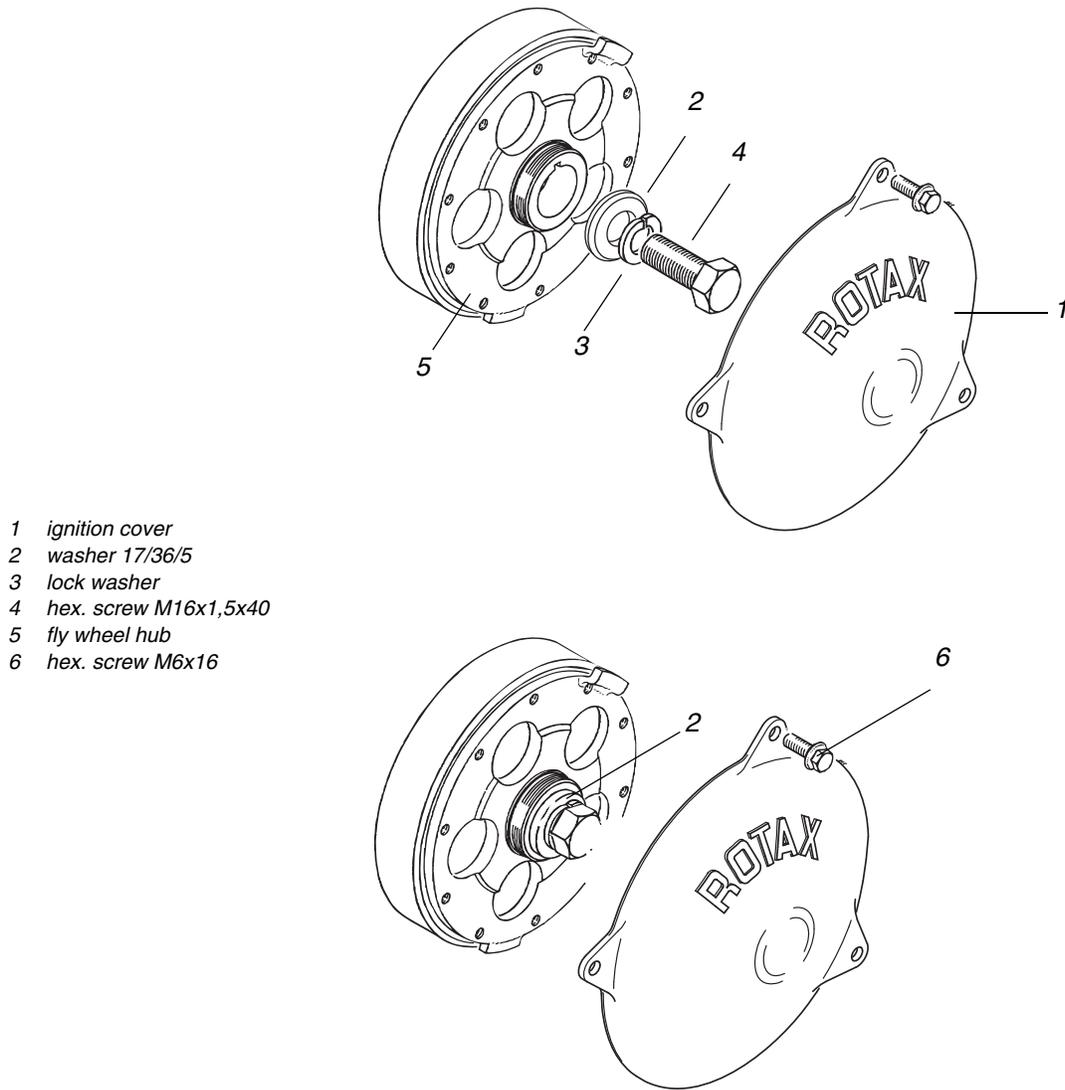
Fig. 1

A deviation in hardening process could cause an exceeding of hardness of certain washer. This deviation could lead to cracks in the washer and could cause loosening of fly wheel, ignition failure or engine damage.

1. Remove ignition cover (1).
2. Lock the crankshaft in accordance with the relevant Maintenance Manual (Line).
3. Remove hex. screw (4) in accordance with the relevant Maintenance Manual (Heavy).

■ CAUTION: If the fly wheel hub has loosened during the disassembly and/or in case of doubt, then remove, clean and install the fly wheel hub in accordance with the relevant Maintenance Manual. In this case the tightening torque is 45 Nm (33.2 ft.lb) + 180° angle to rotation.

4. Install hex. screw (4). **Tightening torque 120 Nm (89 ft.lb).**

■ CAUTION: During installation the new washer (2) part no. 944072 must be used.

5. Remove locking pin of crankshaft in accordance with the relevant Maintenance Manual.
6. Check trigger coil gap, if necessary adjust it in accordance with the relevant Maintenance Manual.
7. Install ignition cover (1). The hex. screws (6) are locked with Loctite 221. Tightening torque 5 Nm (44 in. lb.).
